HOFFMAN CONSTRUCTION COMPANY

UTILITY LEVEL MOD1

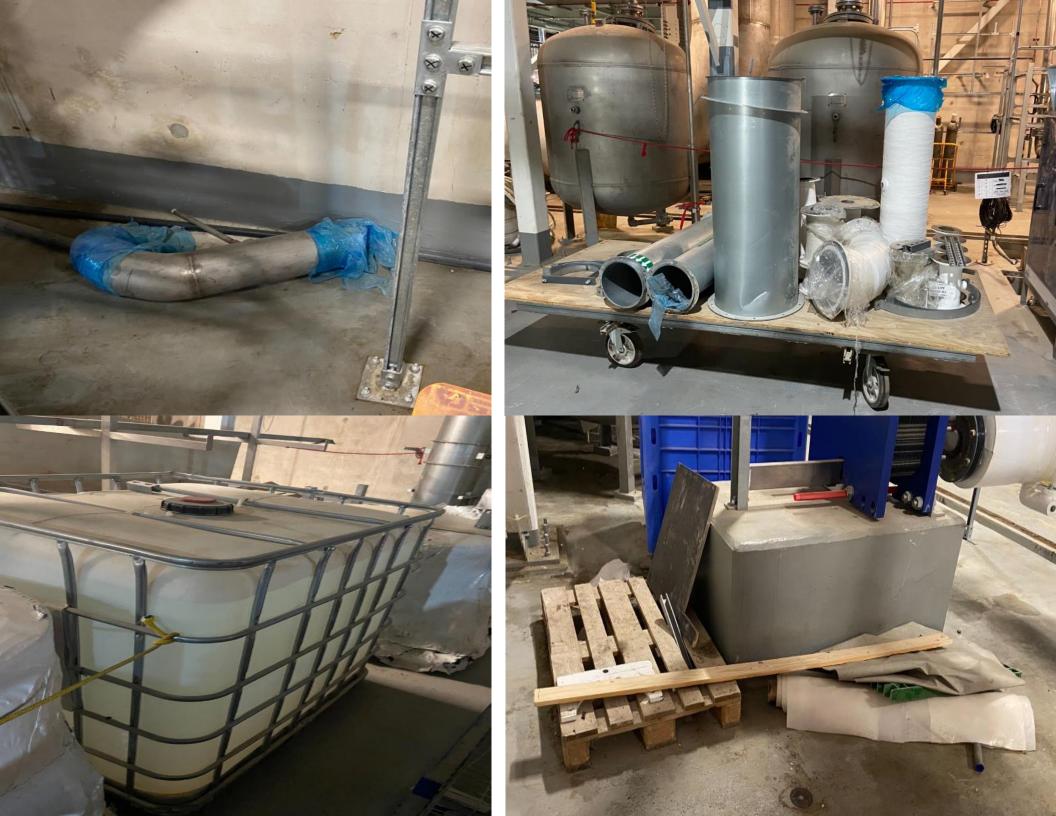
UNRECOGNIZED MATERIALS & TOOLS PLEASE LOOK AT THESE MATERIALS TOOLS OR GO LOOK AT MATERIALS TOOLS SHOUD CLEAR OUT TILL 06.05.25

AT 07.06.25 JOB SERVICE WILL THRU IT TO DUMPSTER

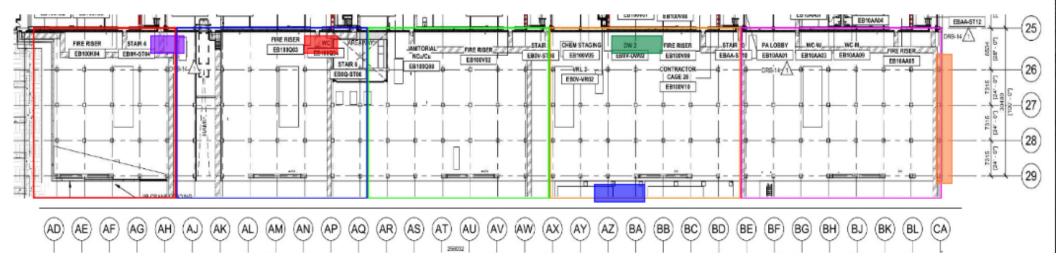
WJG - UL

PACH TAAS install upn 135	PACH TAAS wall penetration	CARMEL BIDUD Measurements and punch list	SK punch list
